Cracking Of Asphalt Concrete Pavements Associated With Absorptive Aggregates

CRACKING OF ASPHALT CONCRETE PAVEMENTS ASSOCIATED WITH ABSORPTIVE AGGREGATES

RESEARCH REPORT

NO. M & R 231138-2

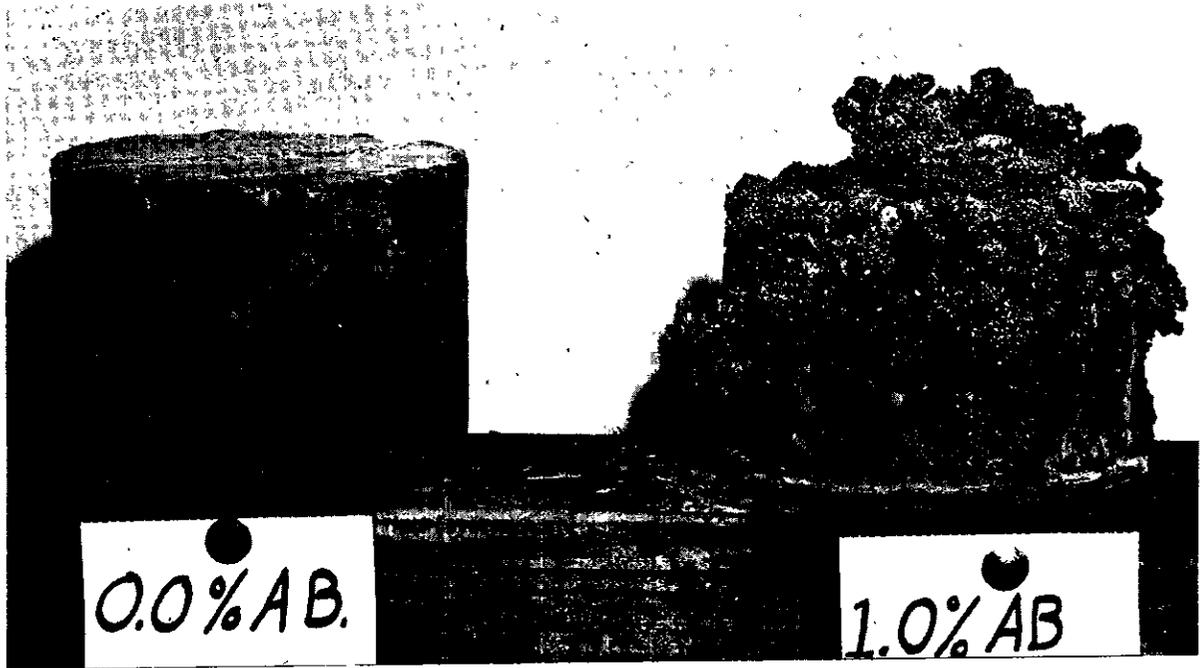
Fig. 1 - Epoxy coated specimen after 1 year exposure on roof.
Left - Nonabsorptive aggregate.
Right - Absorptive aggregate.

After one year's exposure the highly absorptive specimens had completely ruptured the epoxy coating, while the nonabsorptive capsulated specimens remained in excellent condition (Figure 1).

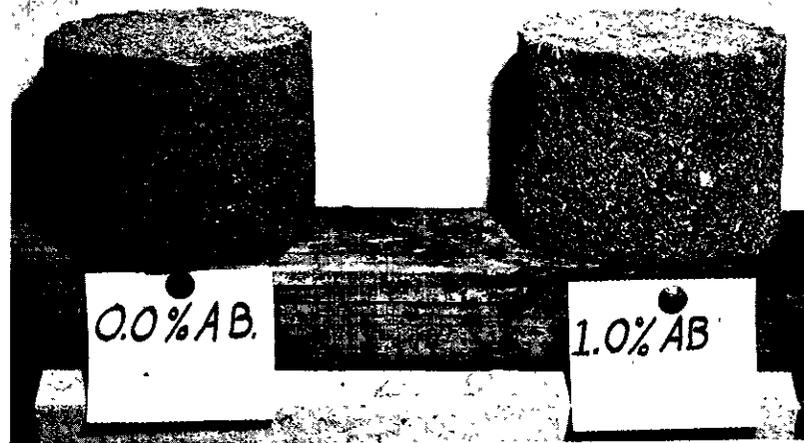
Fig. 2 - Noncapsulated specimen exposed on roof after 6 months.
Left - Nonabsorptive aggregate.
Right - Absorptive aggregate.

The specimens that were left uncoated showed the same

trend. The absorptive briquettes had cracked over their entire exposed surface, whereas the nonabsorptive briquettes showed no signs of distress (Figure 2).

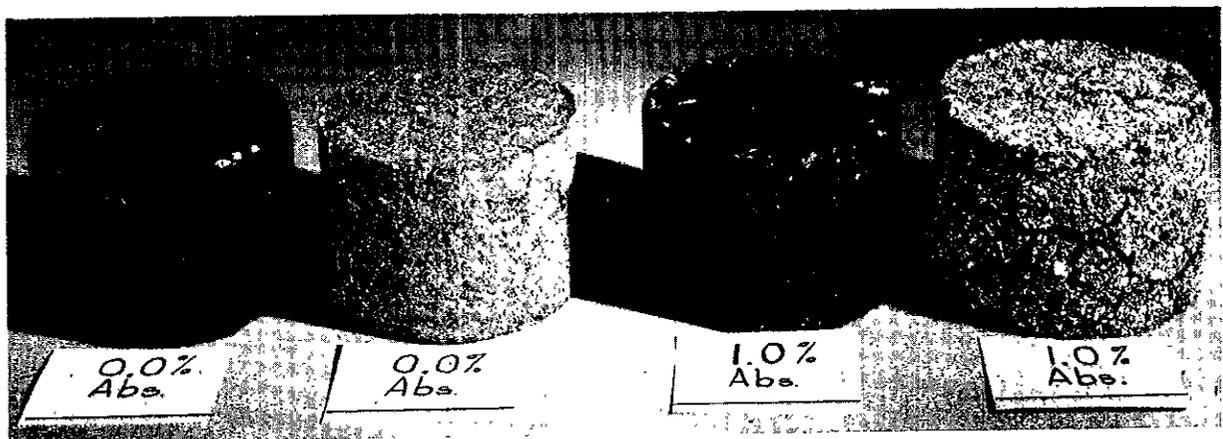
Fig. 3 - Absorptive and nonabsorptive AC briquettes.
Dark colored specimen stored in cabinet for 6 years.
Light colored specimen exposed on roof for 6 years.

The absorptive and nonabsorptive aggregate specimens stored in a cabinet at room temperature in the laboratory building free from sunlight and moisture for a period of six years remained in excellent condition. In comparison, identical specimens stored on the roof are shown in Figure 3.

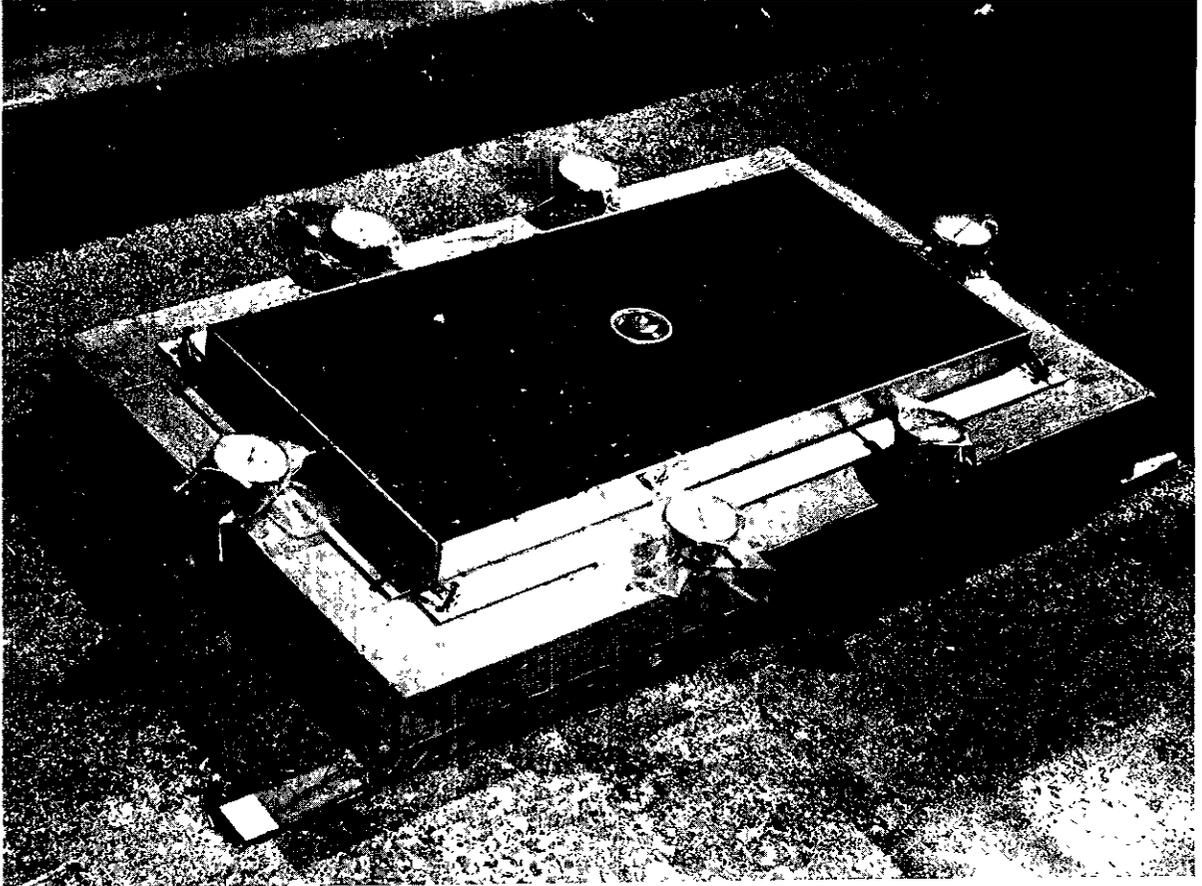
Fig. 4 - Slab specimen 1' x 2' x 3". Note springs holding aluminum sides surrounding surface course.

The test slab was compacted in a heavy wooden frame. After compaction, the top portion of the sides was removed and replaced with free moving aluminum sides which permitted unrestrained expansion and contraction of the specimen. The unrestrained movement was recorded by six dial indicators (reading to the nearest .001") located around the surface as shown in Figure 4.

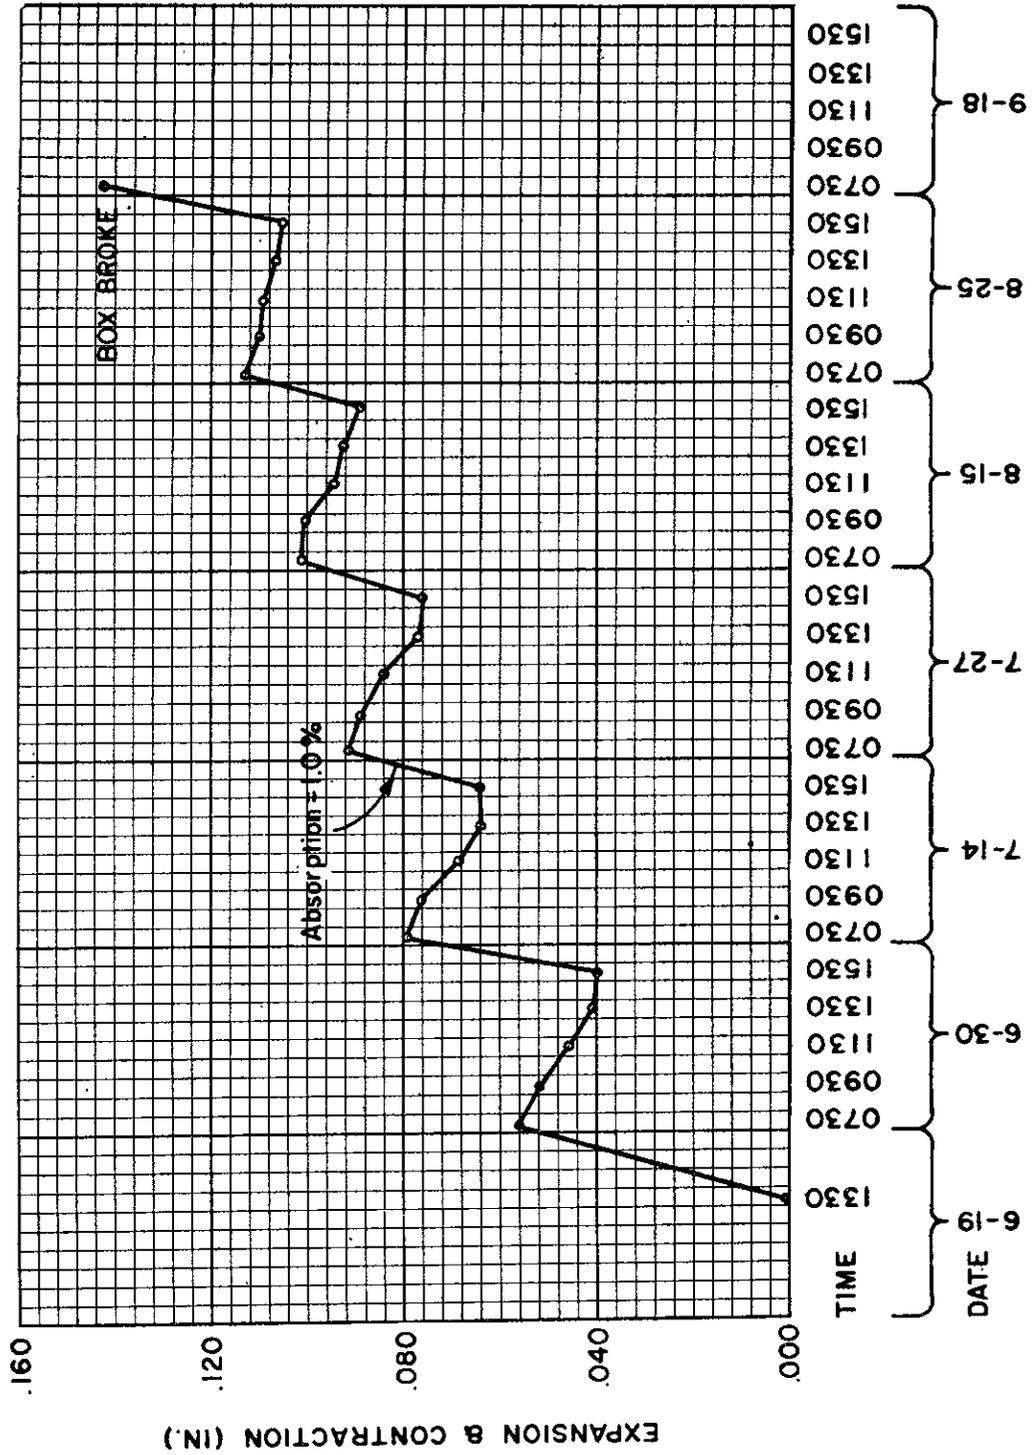
FIGURE 5

TEST NO. 57-1236

This slab was exposed to the outside atmosphere in the early summer of 1961. Dial readings and temperature measurements were made five times daily. Figure 5 shows the expansion that occurred in a three month test. The cyclic pattern shows that maximum expansion occurs during the early morning hours when there is a considerable amount of moisture in the air. Maximum contraction occurs during the warmest hours of the day. It is noteworthy that the specimen failed to return to its original dimension during the contraction period, possibly due to aggregate breakdown during the moisture cycle. The maximum expansion of 0.142" generated sufficient force to break the frame. This occurred soon after an early unseasonable rainstorm.

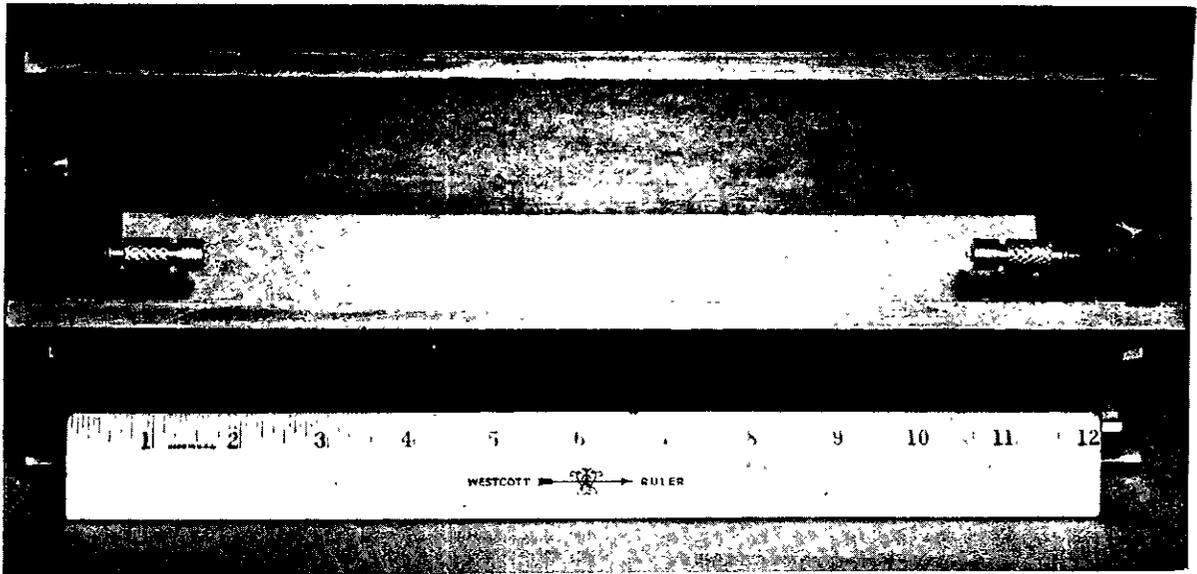
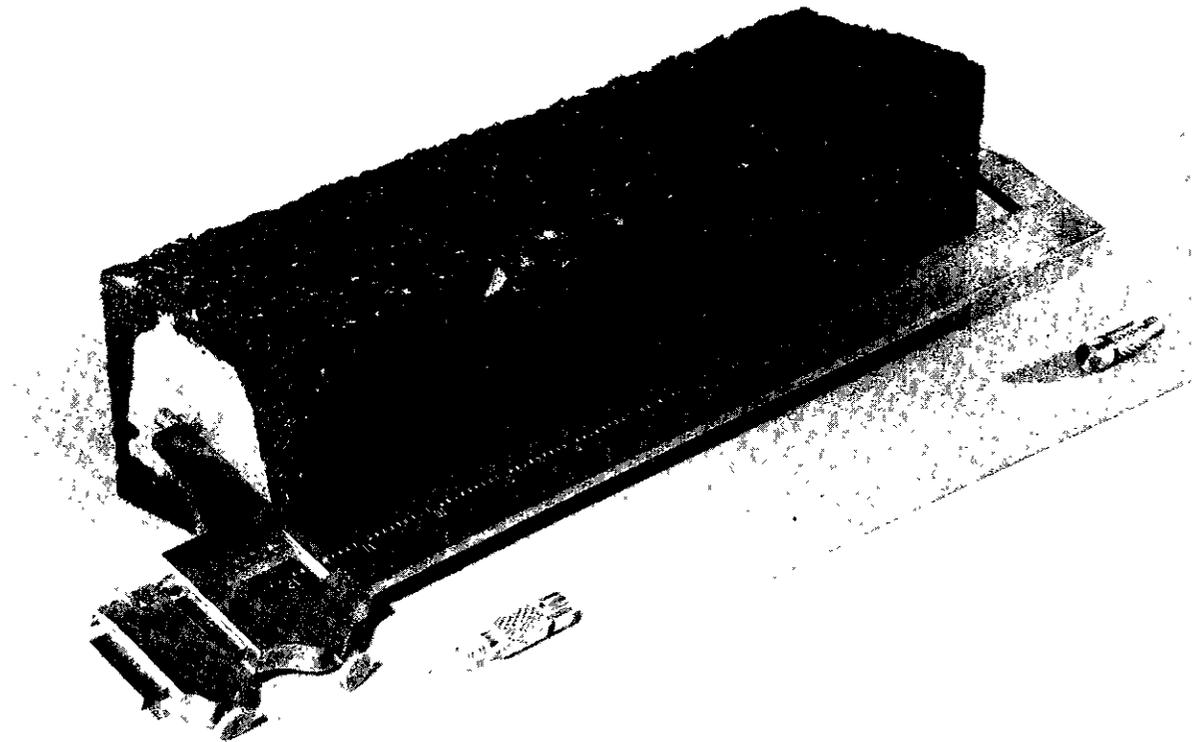
Fig. 6

Steel molds 3" x 3" x 11.25" used for fabricating bars.
Note steel pins in end of plates for measuring AC bars.

Bar after being stripped, ready for measurement.

Because of the expense and time involved in fabricating the large slab specimens, a new method, still currently in use, was adopted. It consists of compacting the AC mix into 3" x 3" x 11.25" long steel molds (Figure 6) using our kneading compactor. (For details of fabrication see Reference 1.) After cooling, the mold is stripped and the steel pins at the ends of the compacted bar are fastened with epoxy. The bars are then cured at 100^oF for three days before being subjected to the weathering cycles. Each weathering cycle consists of seven days in the moisture room followed by seven days drying in a 100^oF oven. The specimens are subjected to from three to six weathering cycles during which daily measurements and observations are made. The measurements are made with a micrometer to the nearest 0.001" as shown in Figure 6.

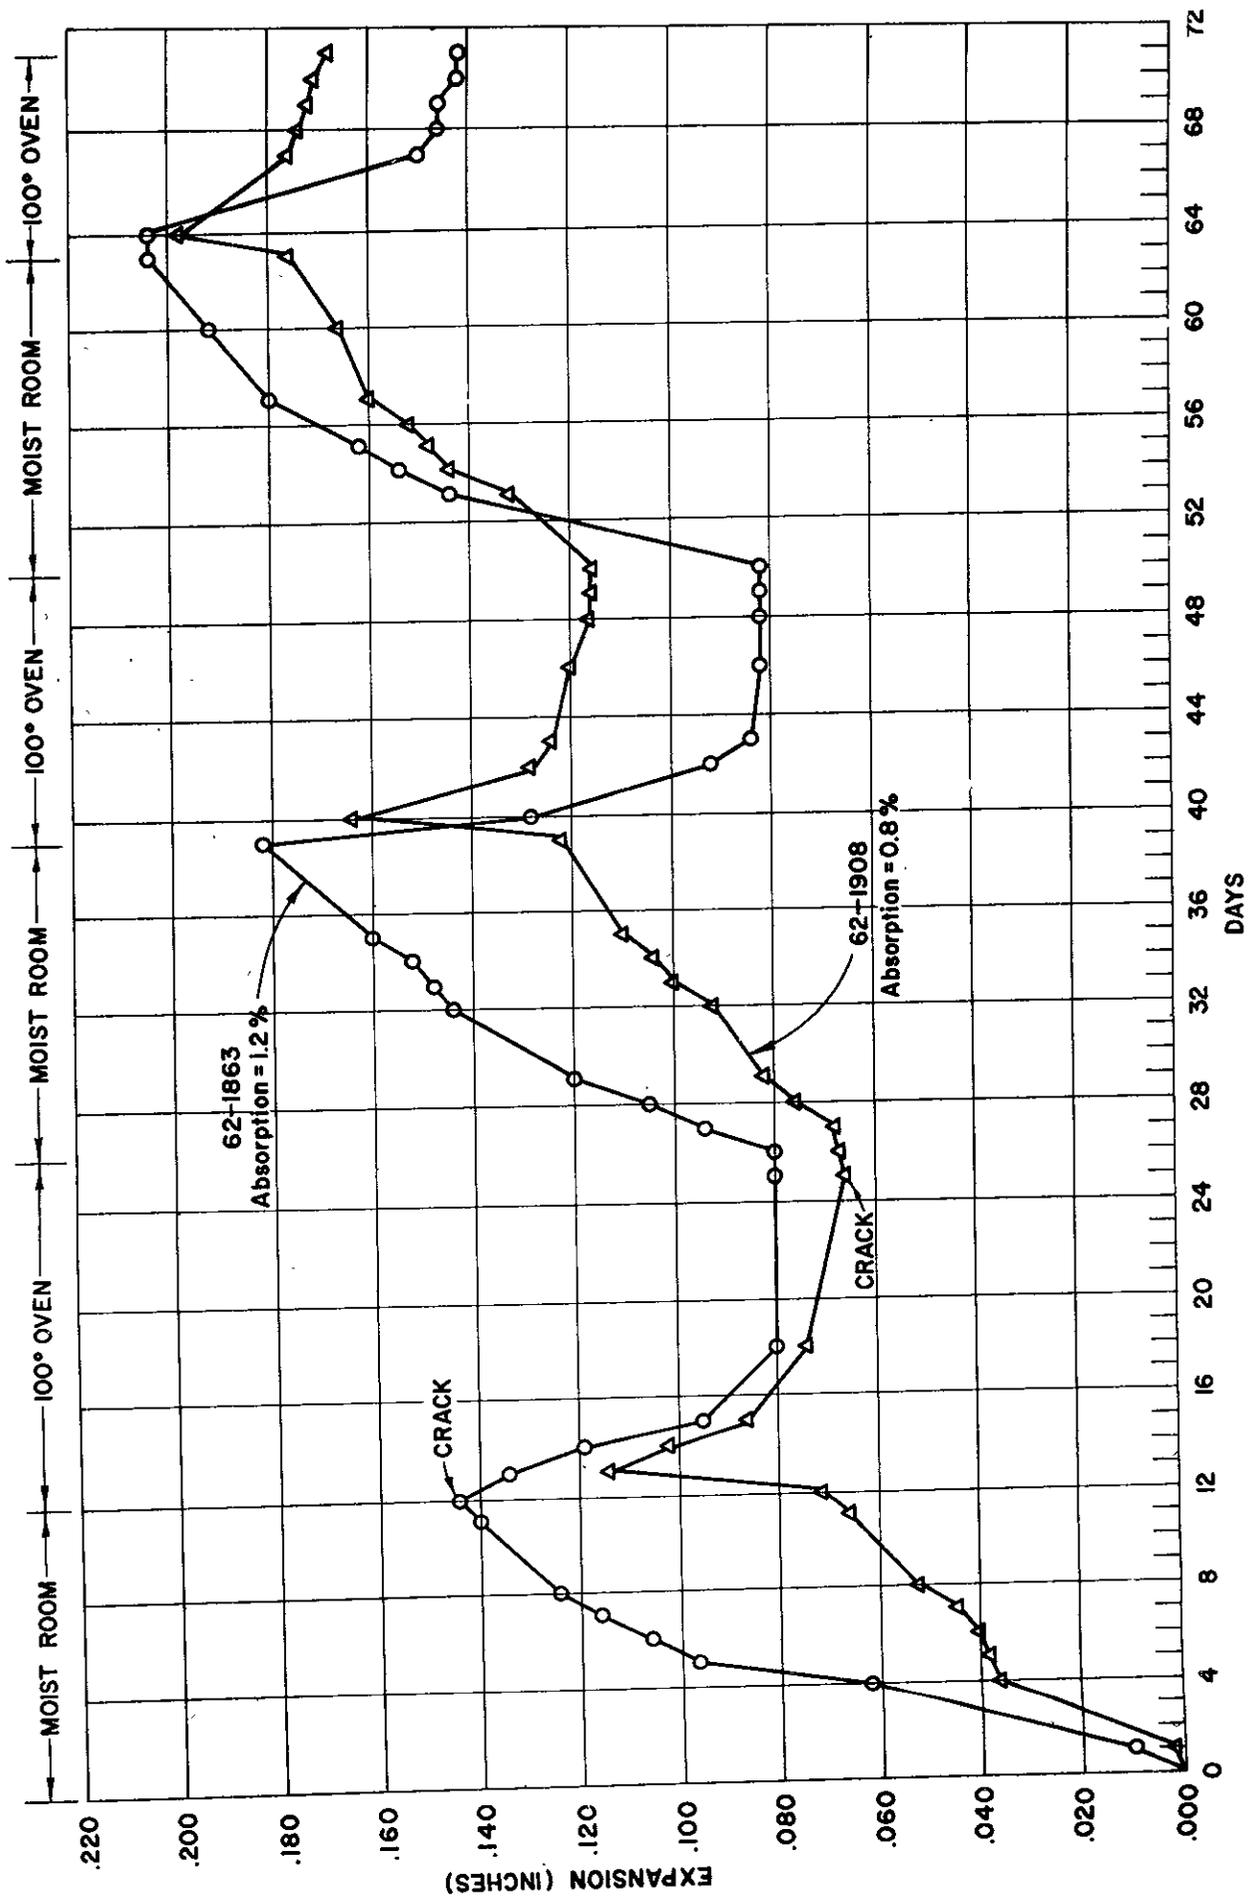
FIGURE 7

TEST NO'S. 62-1863 & 62-1908

Figure 7 represents results from AC bars tested by this method. The bars were fabricated from highly absorptive aggregates from two different sources.

Cracks appeared in Sample #62-1863 during the drying period of the first cycle. During the third cycle the sample had expanded over 0.2" and was cracked throughout its entirety. This expansion (0.2" in a 11.25" bar or 1.8%) is the maximum longitudinal increase recorded to date for AC bars. This condition was reached after 64 days' (Figure 7) exposure to wet and dry periods.

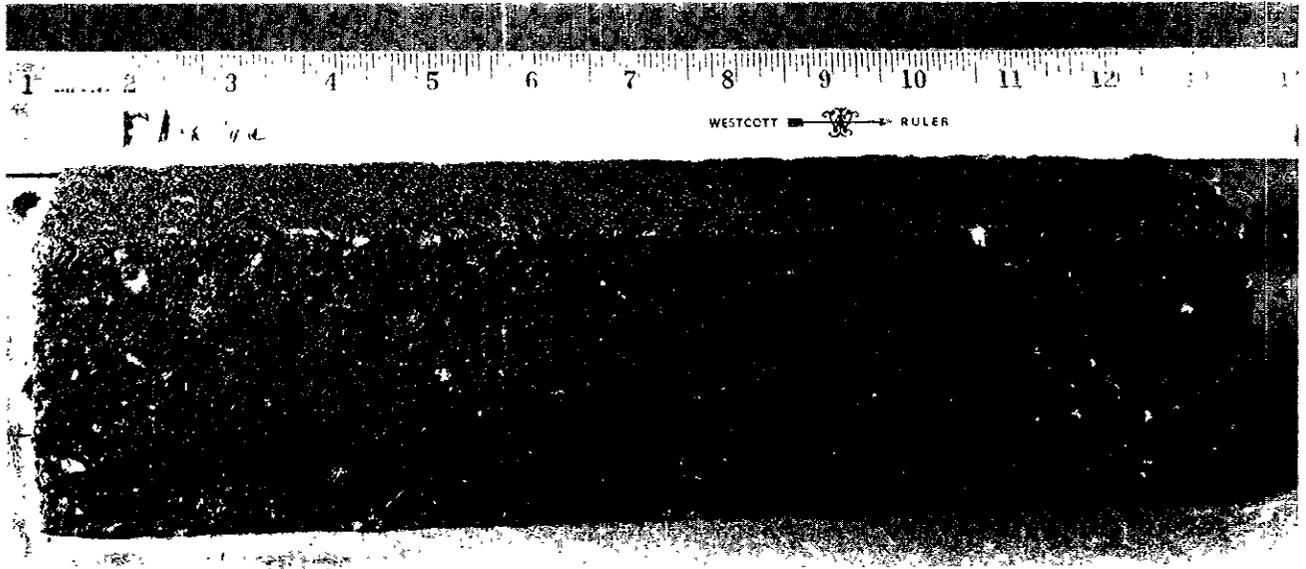
Fig. 8 - Test bar 62-1908.
Transverse cracks appeared after the first cycle.

Transverse cracks were visible on Sample #62-1908 at the end of the first cycle (Figure 8). Rapid expansion (0.045") at the beginning of the drying cycle would indicate that this specimen was susceptible to moisture in the vapor state. Subsequently, several transverse cracks were observed at the end of the third cycle. This specimen required 13 days in the 100°F oven before contraction became constant which, as stated, was probably due to its susceptibility to moisture vapor. Our data indicate that the average time required for maximum expansion and contraction is approximately seven days for each wet and dry cycle.

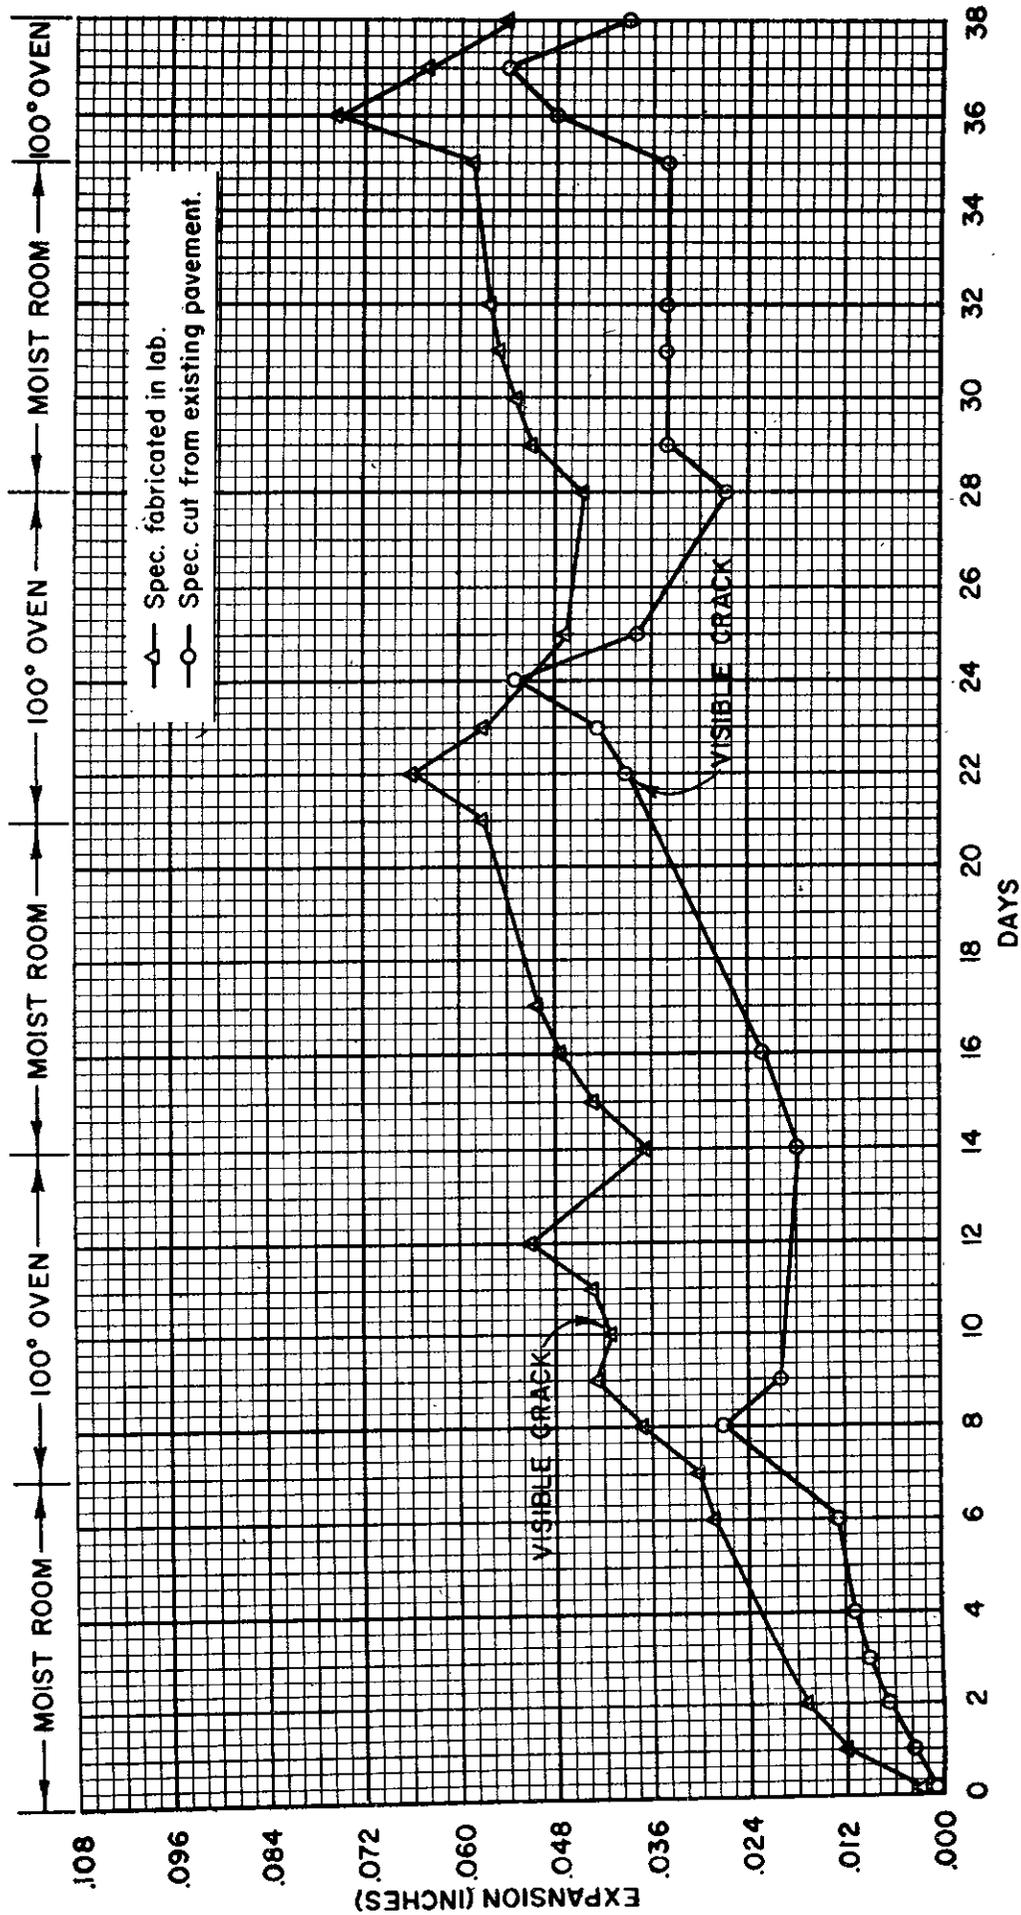
FIGURE 10

TEST NO. 62-5748

A record of the expansion and contraction occurring in the laboratory-fabricated specimen and the AC sample bar sawed from existing pavement is presented graphically by Figure 10. Both AC bars showed approximately the same rapid expansion in the first few hours of the dry cycle. However, the laboratory-prepared bar expanded more during the wet cycle, probably due to the fact that the asphalt in the specimen from the existing pavement had a longer time to be absorbed by the absorptive aggregates (both fine and coarse). This added depth of penetration of asphalt into the aggregates partially sealed off the pores of the aggregates and prevented it from absorbing water thus reducing expansion during the wet cycle.
