# **Full-Depth Pavement Reclamation with Foamed Asphalt: First-Level Analysis Report on HVS Testing on State Route 89**

Partnered Pavement Research Program (PPRC) Strategic Plan Element 4.12: Development of Improved Mix and Structural Design and Construction Guidelines for Full-Depth Reclamation with Foamed Asphalt

This report focuses on the HVS testing of a foamed asphalt treated, reclaimed asphalt pavement (RAP) on State Route 89 near Sierraville. The report discusses the expected behavior of the HVS test sections, presents the results from field surveys done during June 2003, October 2003 and May 2004 as well as the 1st level analysis of HVS results from the test site. Results from field surveys done prior to, during and after HVS testing show that the pavement structure of the HVS test sections on SR89 is not representative of the mainline and foamed asphalt treated, reclaimed asphalt concrete in general.

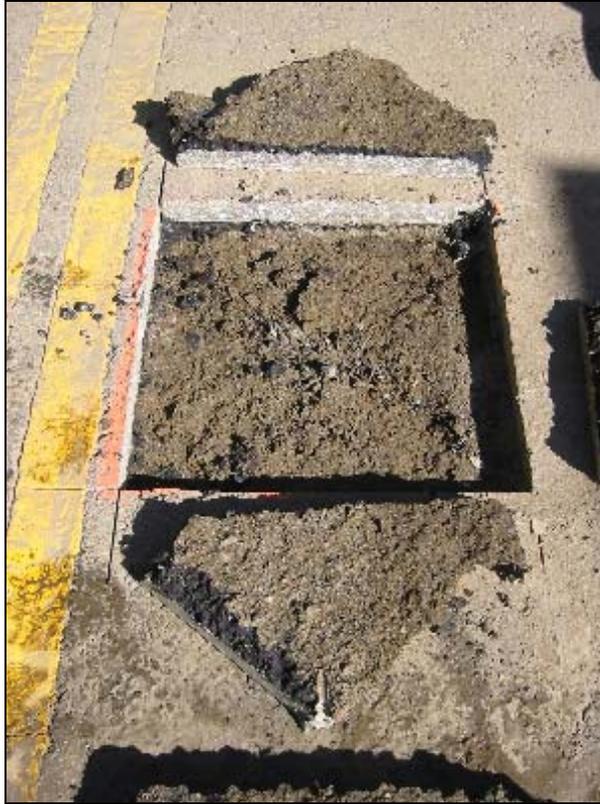
The photograph in Figure 4.19 shows the asphalt concrete surfacing removed from the test pit that was excavated on the mainline. There was a good bond between the asphalt concrete surfacing and the foamed asphalt treated base. A large piece of intact reclaimed asphalt was found in the base layer during excavation as shown in Figure 4.20. The support of the foamed asphalt treated base layer in the test pit was also found to differ. The support for the southbound lane appeared to consist of decomposed granite while that of the northbound lane appeared to consist of an old oil-based pavement as shown in the photograph in Figure 4.21 (bottom of the test pit).

**Figure 4.19: Asphalt concrete surfacing removed from the test pit on the mainline.**

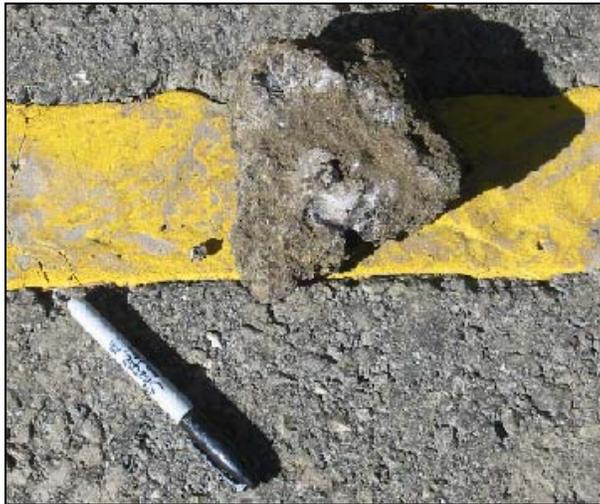
**Figure 4.20: Intact piece of reclaimed asphalt concrete found in the mainline test pit.**

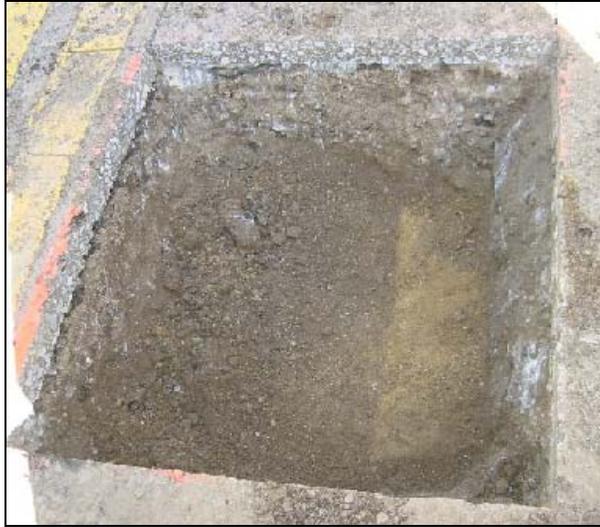
**Figure 4.21: Bottom of mainline test pit showing old oil-based pavement.**

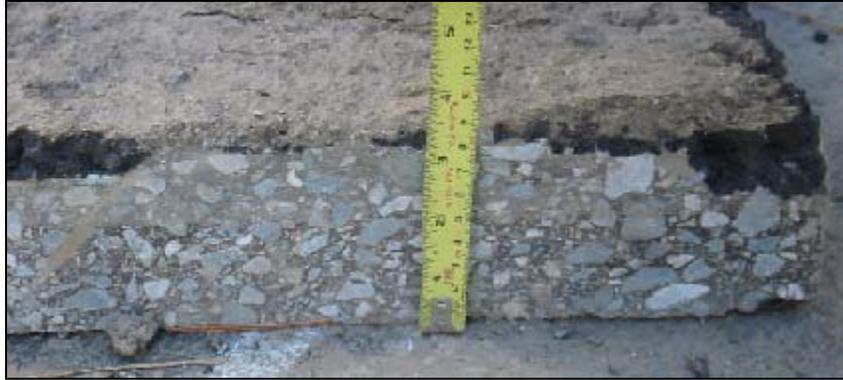
**Figure 4.22: Good bond between asphalt concrete and foam asphalt base layer on Section 593FD.**

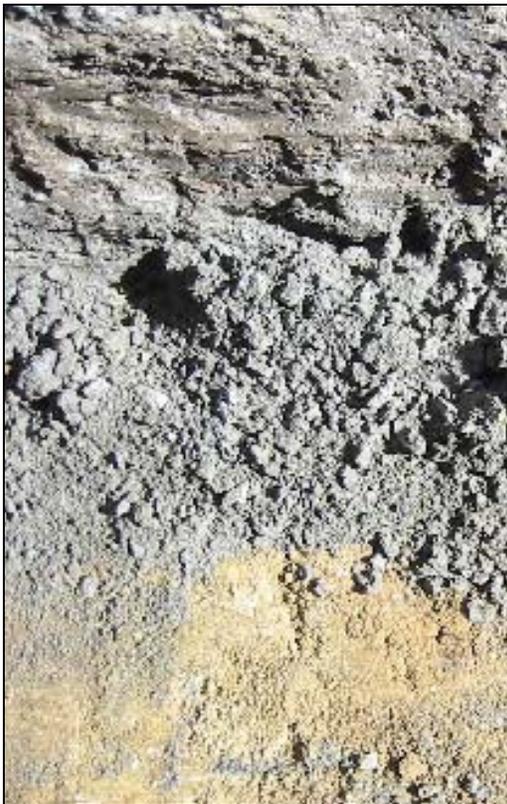
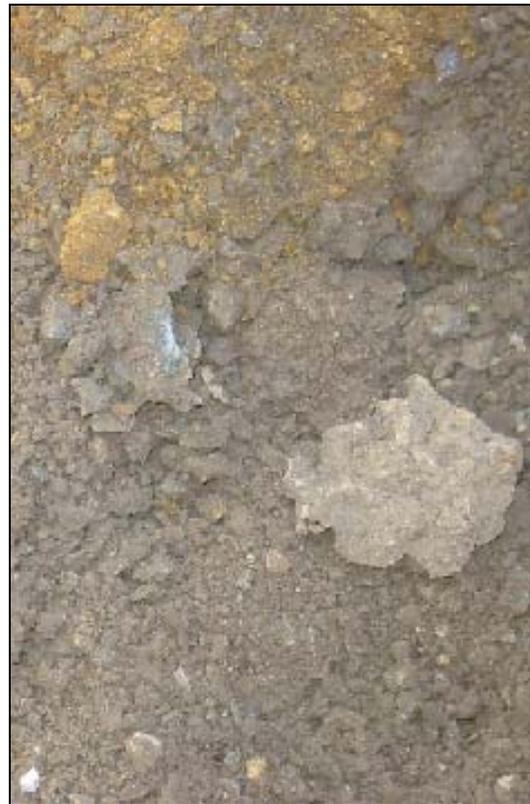
(a) Grey colored material found below the base layer on the HVS lane

(b) The material below the base layer broke out in flaky pieces

**Figure 4.23: Grey, clay like material found below the base layer on Section 593FD.**

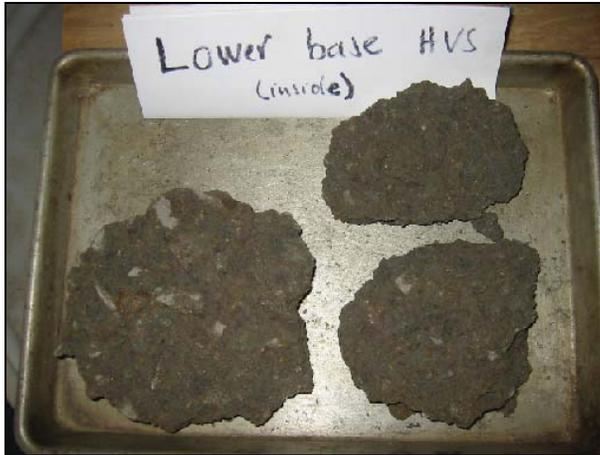
Figure 4.24: Flaky, clay like material from below the base layer on Section 593FD.

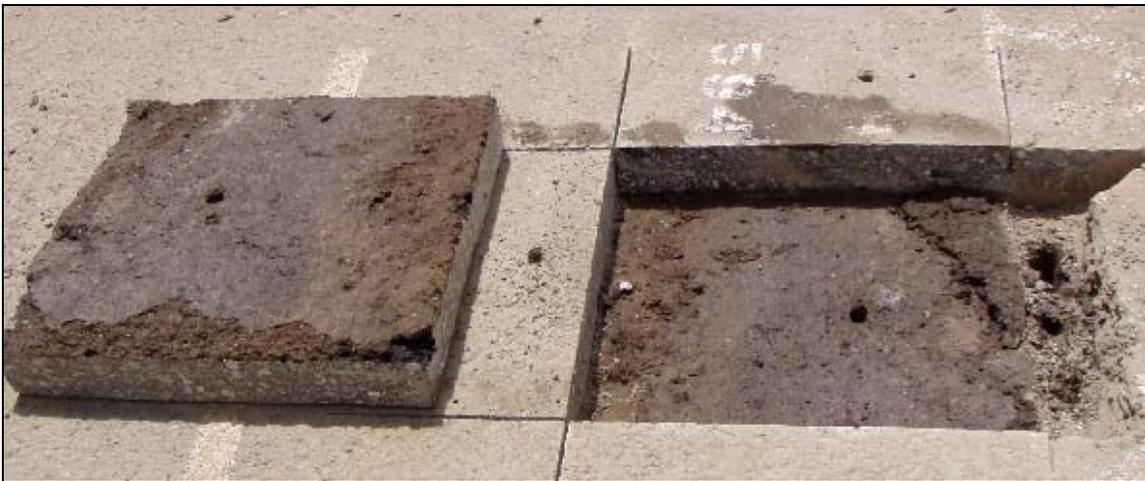
The photograph in Figure 4.27 shows the asphalt concrete surfacing layer removed from the test pit in Section 594FD. Again, there appeared to be a good bond between the asphalt concrete surfacing and the foamed asphalt treated base layer. However, there did appear to be some lamination near the top of the foamed asphalt treated base layer.

**Figure 4.27: Bond between asphalt concrete surfacing and the treated base on Section 594FD.**

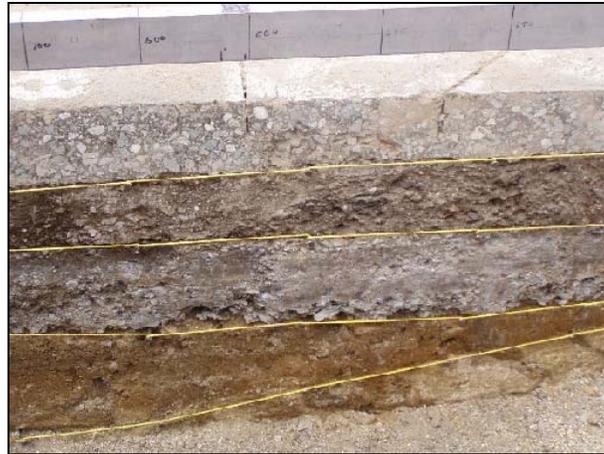
A photograph of a section of the 594FD test pit with the layer interfaces marked with string is shown in Figure 4.28. Grey clay-like material layer was again found underneath the foamed asphalt layer. On this section, the subgrade appeared to comprise of two materials, somewhat randomly placed. The lighter material was sandy weathered granite, while the darker material appeared to have more clay particles. It is thought that the materials are essentially the same, but were procured from different areas when the turnout was constructed. This is discussed in Section 4.2.4.

**Figure 4.28: Test pit on Section 594FD after HVS trafficking.**

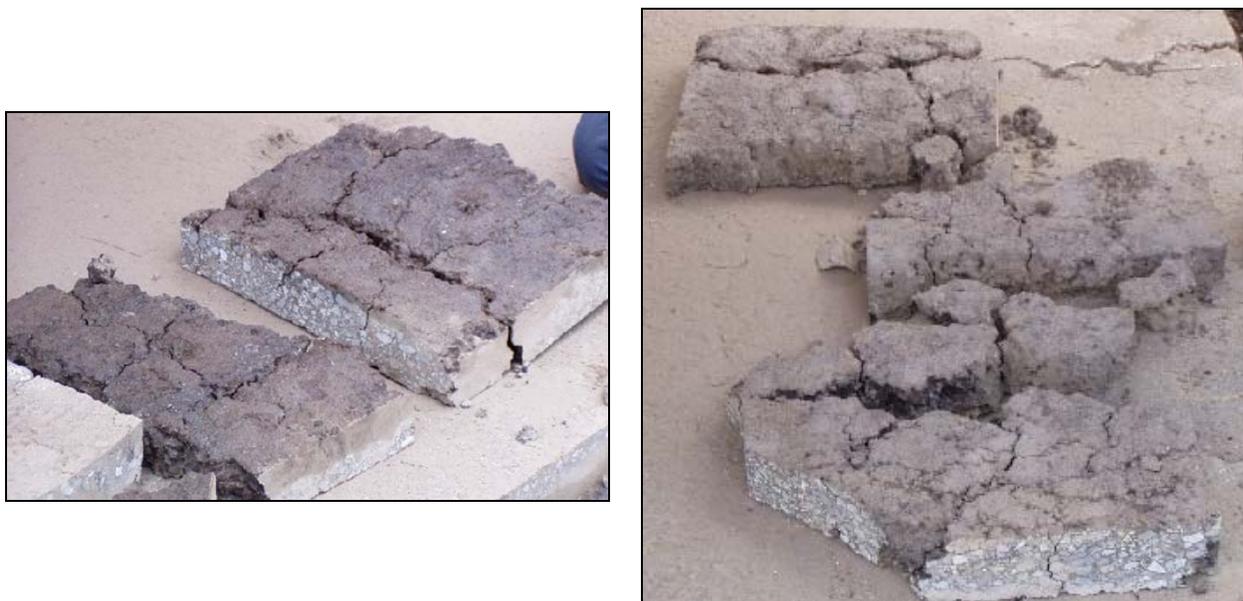
The photograph in Figure 4.30 shows the asphalt concrete surfacing layer removed from the test pit excavated on Section 595FD. This section was cracked through the slab, and the slabs broke up when lifted out of the test pit. The slabs from outside the trafficked area remained intact.

Figure 4.30: Asphalt surfacing from Section 595FD.

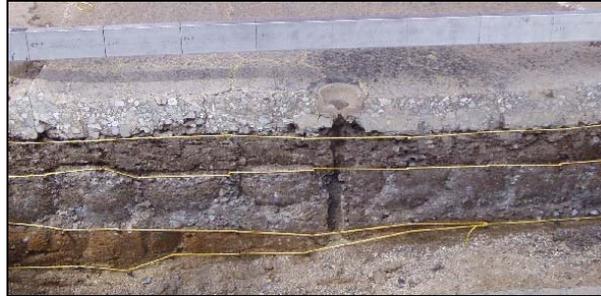
A photograph of a section of the 595FD test pit with the layer interfaces marked with string is shown in Figure 4.31. The grey clay-like material layer was again found below the foamed asphalt layer and materials in the subgrade appear to have been mixed as shown in Figure 4.32.

**Figure 4.31: Test pit on Section 595FD after HVS trafficking.**

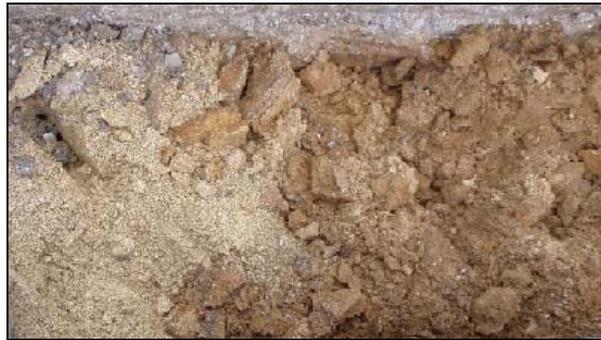
**Figure 4.32: Two materials in subgrade on Section 595FD.**

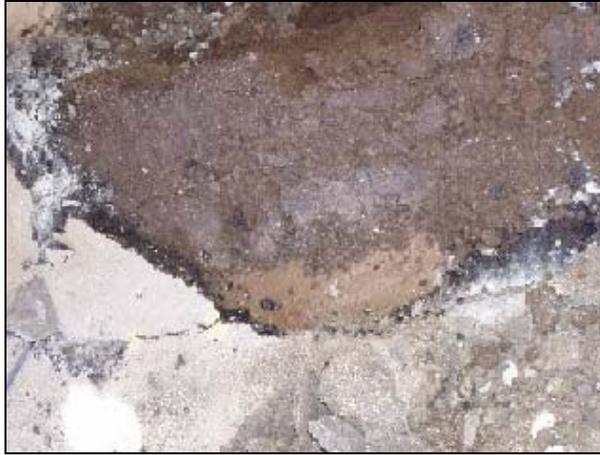
A test pit was opened on the part of Section 596FD that had severe cracking and upward movement on the sides of the test section. When the surfacing was removed, a mud puddle was observed on the side of the caravan side of the test section, illustrated in Figure 4.34. This demonstrates that the water applied to the surface reached the base layer. A large amount of the base material was pushed to the sides of the test section because of this water. This is shown in Figure 4.35 and in the profile in Figure 4.36. Deformation in the layers underneath the base is not evident from the profiles. Average layer thicknesses in the test pit are provided in Table 4.9.

Figure 4.34: Mud between the AC surfacing and treated base, on the side of Section 596FD.

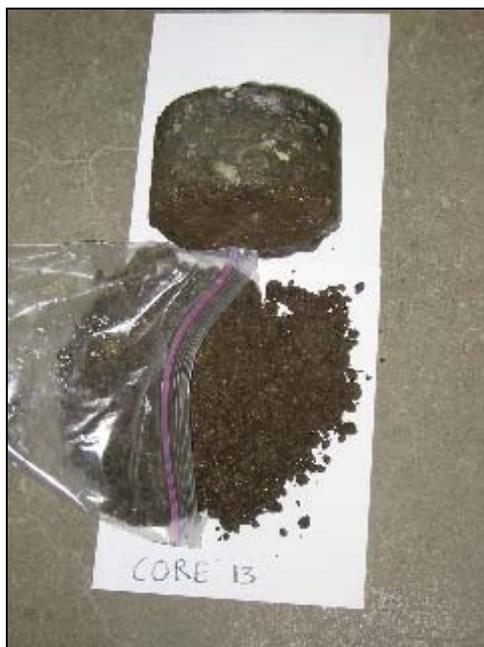
The photographs in Figure 4.41 show cores taken from inside Section 593FD and immediately next to section 593FD. The foamed asphalt treated base appears to have disintegrated under the effect of HVS trafficking as shown by the loose material from Core 13, taken inside the HVS test section. The thicknesses of the asphalt concrete layer were 85 mm on Core 13 and 86 mm on Core 14. The foamed asphalt treated base on Core 14, taken next to the HVS section, came out intact and bonded to the asphalt concrete surfacing layer, but the foamed asphalt treated portion was only 40 mm thick.

(a) Core 13 taken from the HVS test section

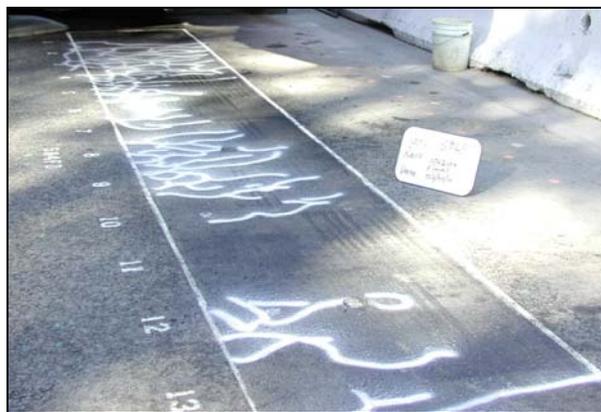
Figure 5.17: Visual condition of Section 594FD at the end of the test.

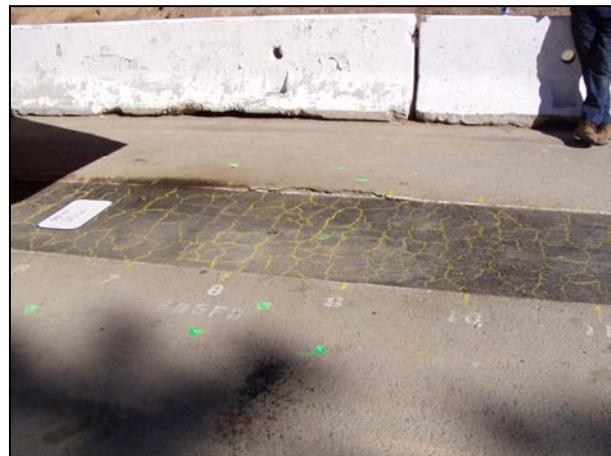
(b) Extensive fatigue of Section 595FD at end of test

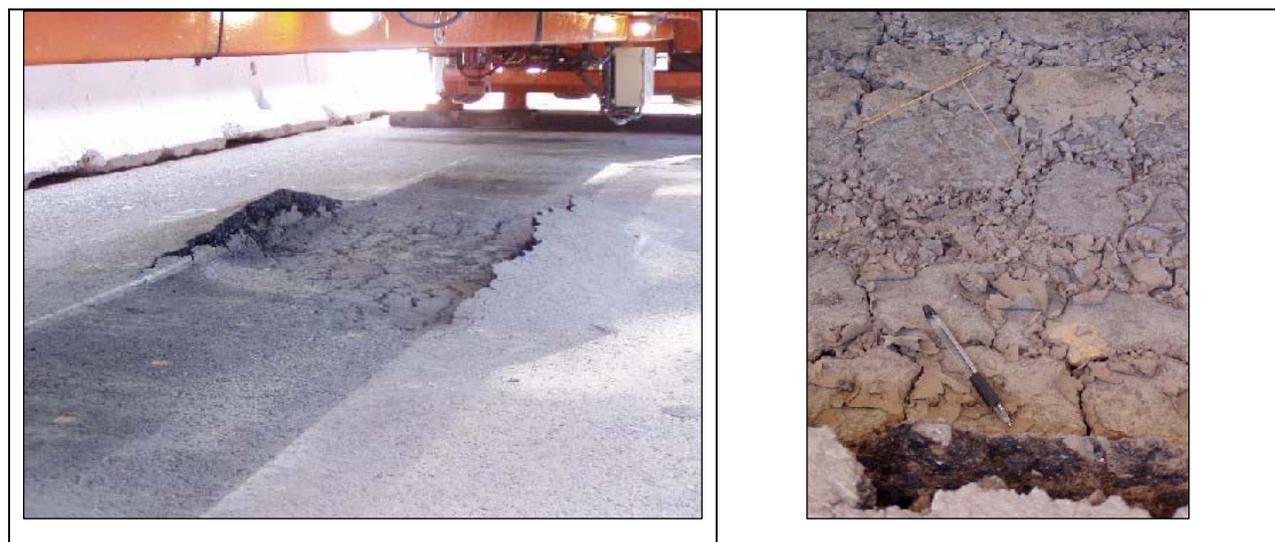
(a) Shear failure between Stations 7 and 8
